# Manhole Inspection Summary

Manhole # S15I\_\_010MH

**Location** Address: **2558 hollins st** Cross Street: **franklintown rd**

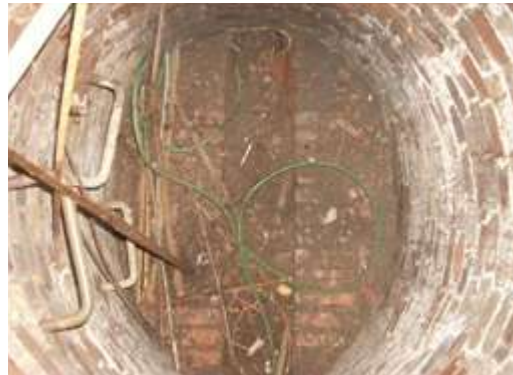
Top View

**Bench** ☒ Exists Material: **Brick** ☐ Parged  
Condition: ☐ Sound ☐ Cracked ☐ Root Intrusion ☐ Deteriorated ☐ Leaks ☒ **Debris**

**Channel** Material: **Brick** ☐ Parged  
Channel Exposure: **Fully Open** Junc Dist: **0** nearest .5 ft. Azimuth: **0**  
Condition: ☐ Sound ☐ Cracked ☐ Root Intrusion ☐ Deteriorated ☐ Leaks ☒ **Debris**
